## **Executive Summary**

**WATERS OF THE UNITED STATES DELINEATION-  
CUTLASS SOLAR II PROJECT  
FORT BEND COUNTY, TEXAS**

## **1.0 PROJECT INTRODUCTION**

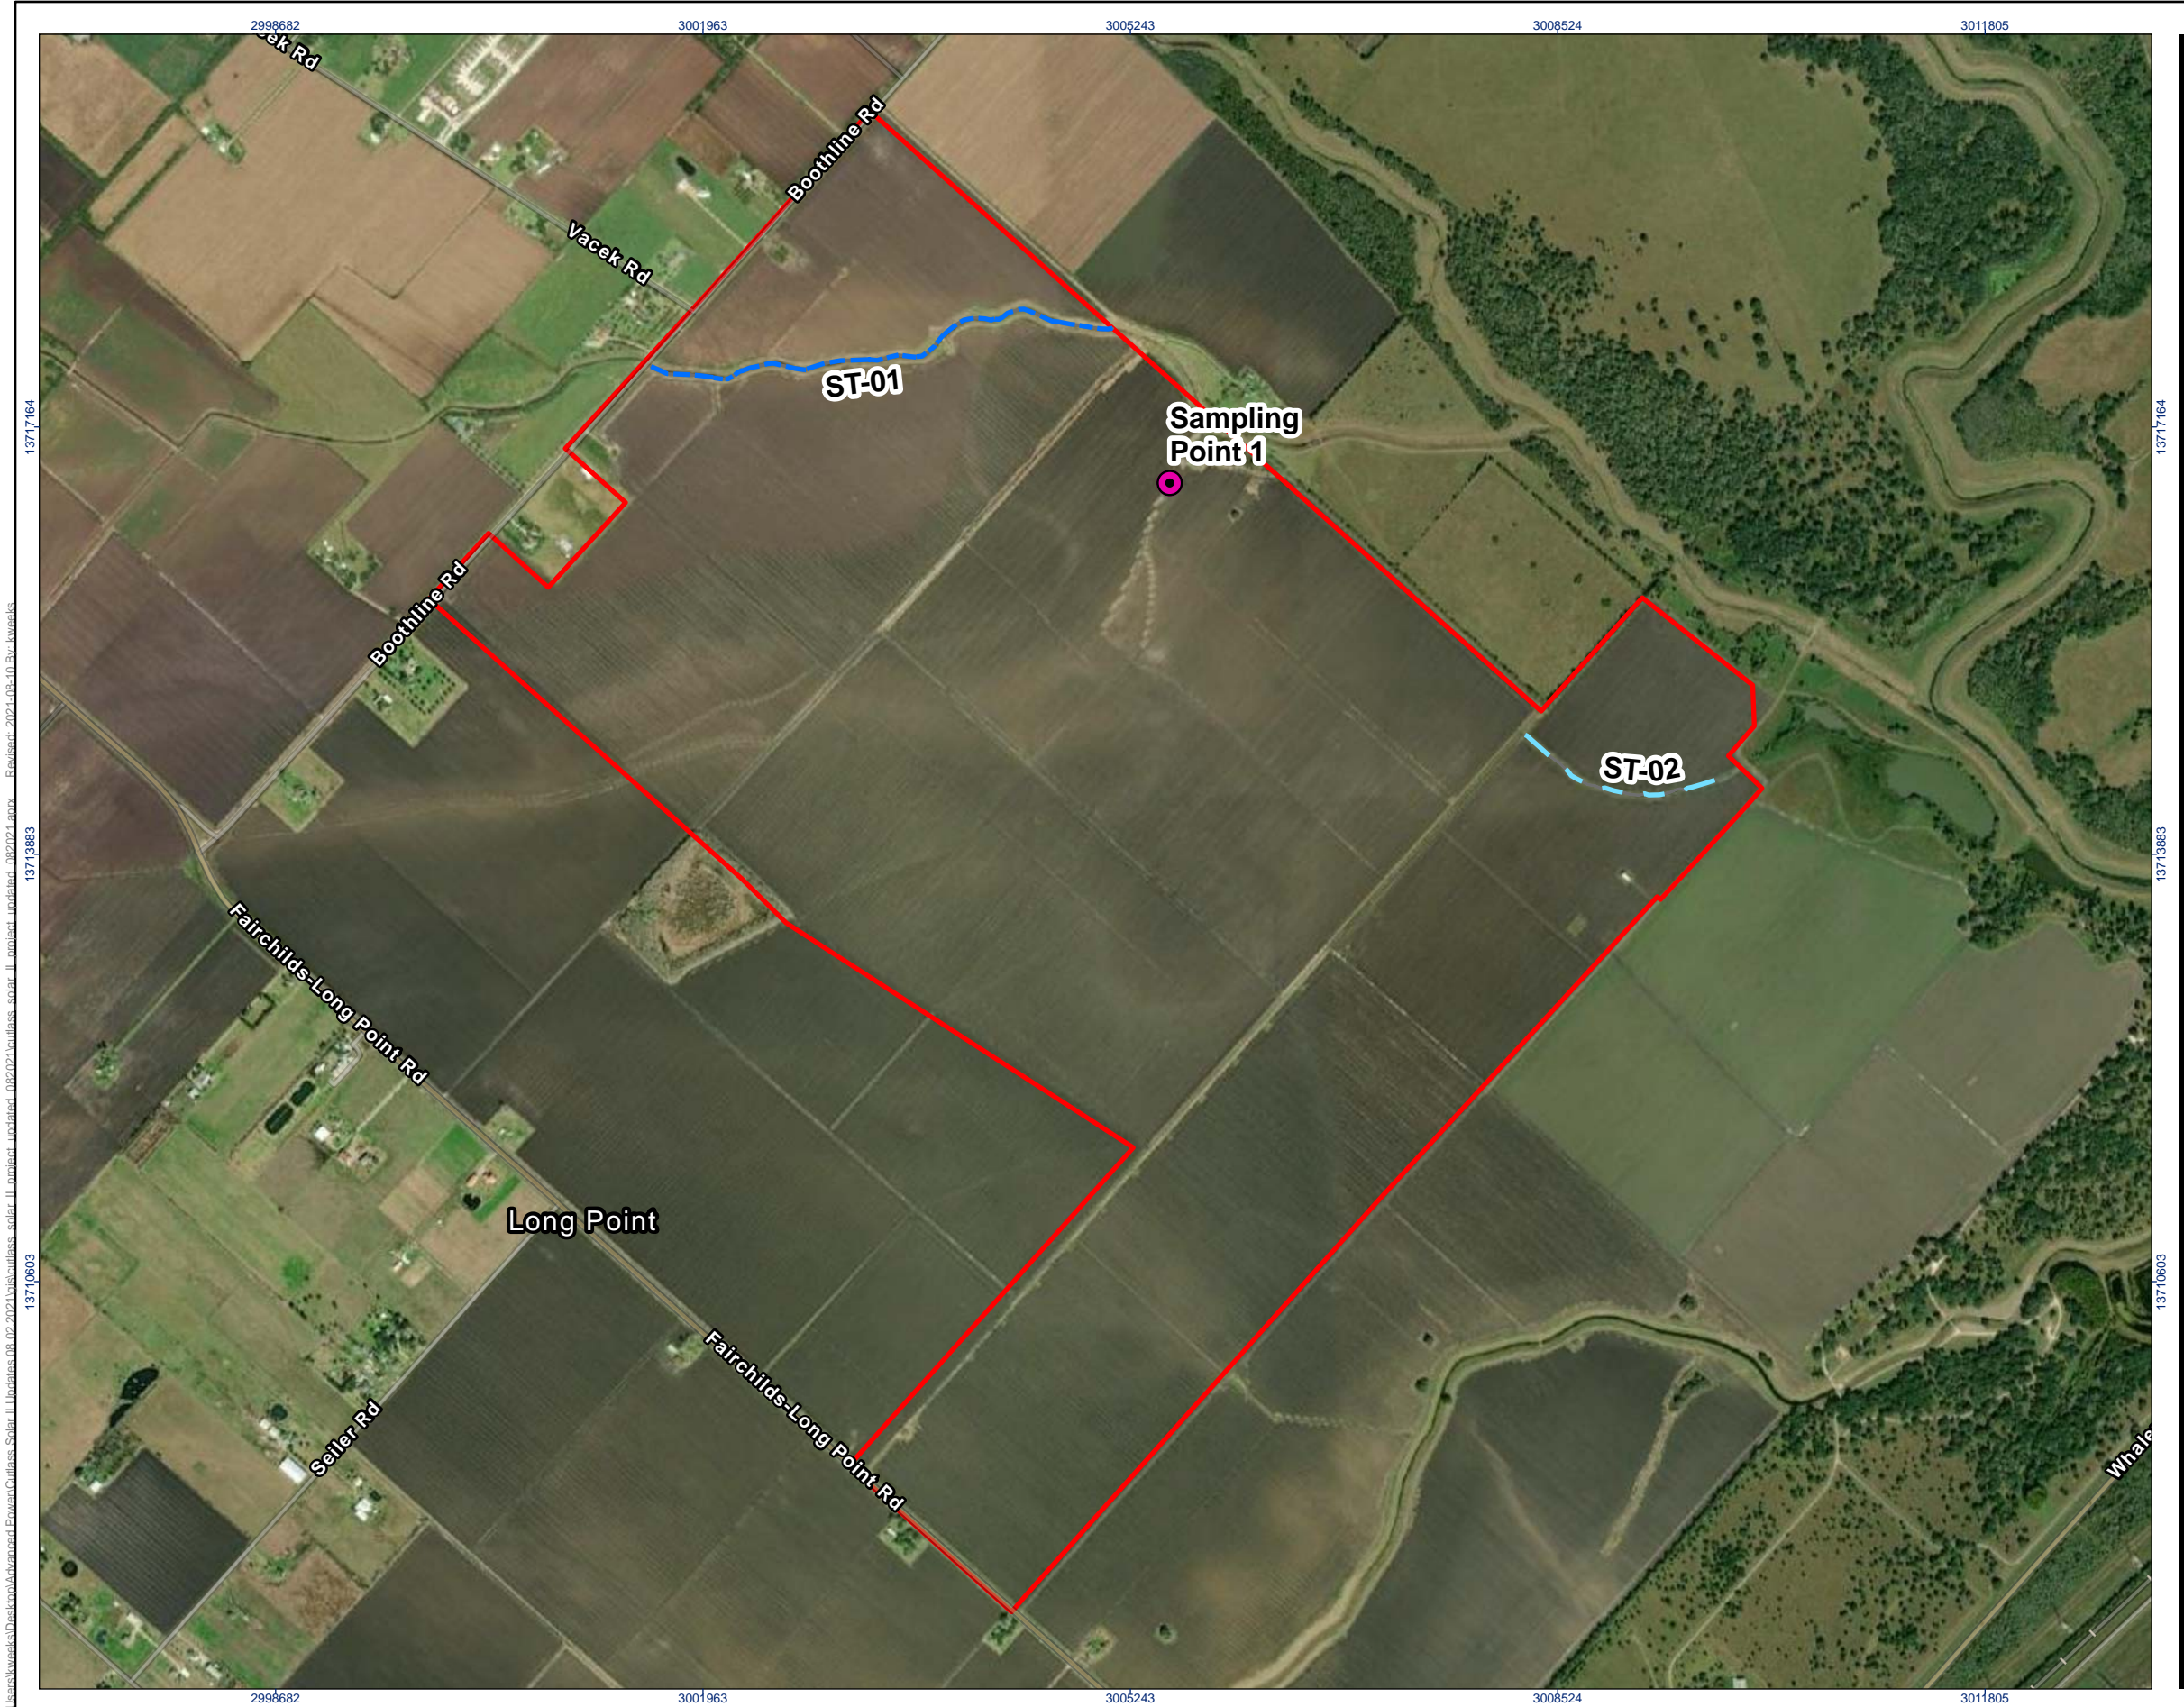
Figure No.  
**6**

Maps were created using the field-collected data to illustrate the locations of all delineated features within the Project Area and are depicted on **Figure 6** in **Appendix A**. Photographs were taken of all delineated features within the Project Area and are provided in **Appendix B**. A map indicating the location of photographs is also provided in **Appendix B**.

Two streams were delineated within the Project Area. No wetlands were identified within the Project Area during the field investigation. The location of all field delineated features and the sampling point is provided in **Appendix A, Figure 6**. Wetland determination forms completed at each sampling point within the Project Area are provided in **Appendix D**. The potential jurisdictional status of features delineated within the Project Area were determined based on Stantec's understanding of the current regulatory guidance.

Stantec identified and delineated two streams within the Project Area, totaling approximately 0.52 acres (5,400.3 LF). ST-01, a field verified NHD intermittent stream, was found in the northern boundary of the Project Area. ST-01 is an unnamed tributary to Fairchilds Creek and is fully encompassed by tall banks with culverts which appear to drain the adjacent fields.

ST-02 was not mapped by any public resource and appeared to be an ephemeral channel. ST-02 was identified as a small, unnamed, ephemeral stream draining towards Fairchilds Creek. Vegetation of the stream channel was not indicative of wetland vegetation as ST-02 was an area draining cropland and was largely characterized as located in a denuded area. No open waterbodies or wetland hydrology indicators were observed within the Project Area. **Table 3** details the streams delineated within the Project Area.

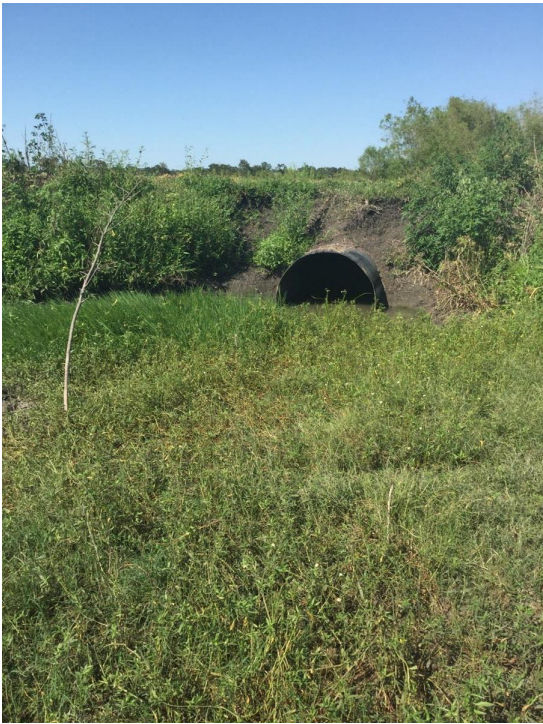
<b>Client:</b>	<b>Cutlass Solar II LLC</b>	<b>Project:</b>	<b>Waters of the United States Delineation</b>
<b>Project Name:</b>	<b>Cutlass Solar II Project</b>	<b>Project Location:</b>	<b>Fort Bend County, Texas</b>
<b>Photograph ID: 1</b>

<b>Photo Location:</b> Sampling Point 1			
<b>Direction:</b> NE			
<b>Survey Date:</b> 7/24/2019			
<b>Comments:</b> Representative view of an upland herbaceous point taken within the Project Area.			
<b>Photograph ID: 2</b>

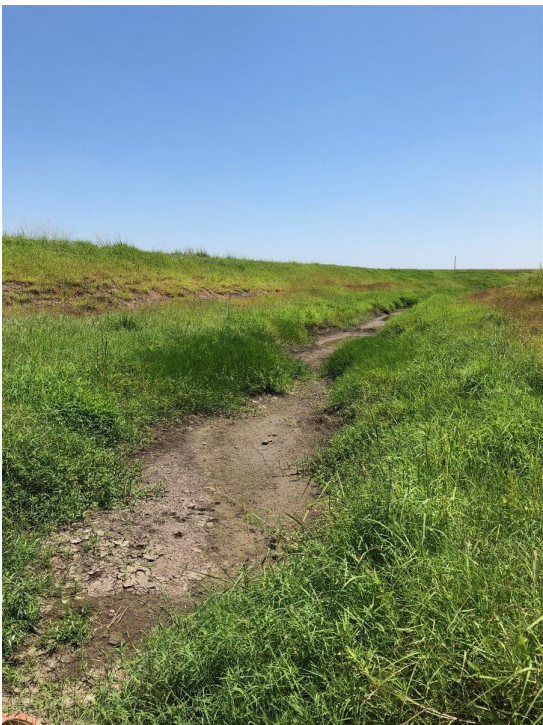
<b>Photo Location:</b> ST-01			
<b>Direction:</b> E			
<b>Survey Date:</b> 7/25/2019			
<b>Comments:</b> Downstream view of ST-01, an intermittent stream.

Vegetation along the unnamed tributary of Fairchilds Creek (ST-01) was found to be primarily herbaceous due to its banks being completely contained within 15-foot-high vegetated banks. ST-01 was surrounded by maintained vegetated banks through most of the Project Area until it approached the northern Project Area boundary where wooded areas were observed.

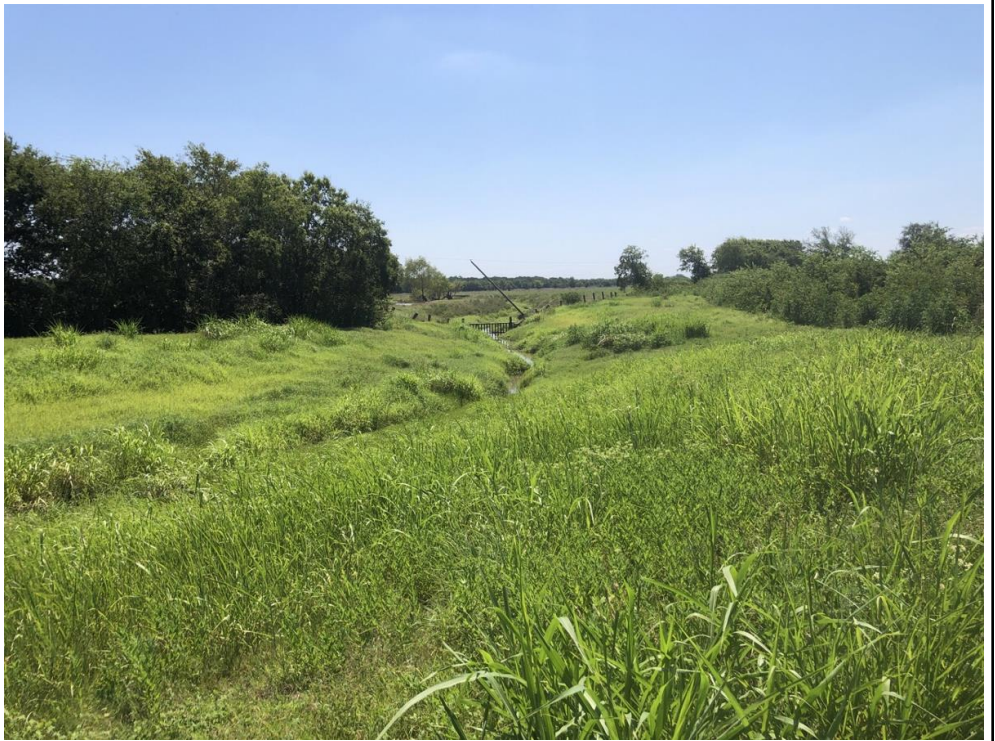
<b>Photo Location:</b> ST-01			
<b>Direction:</b> SE			
<b>Survey Date:</b> 7/25/2019			
<b>Comments:</b> Downstream view of ST-01, an intermittent stream.

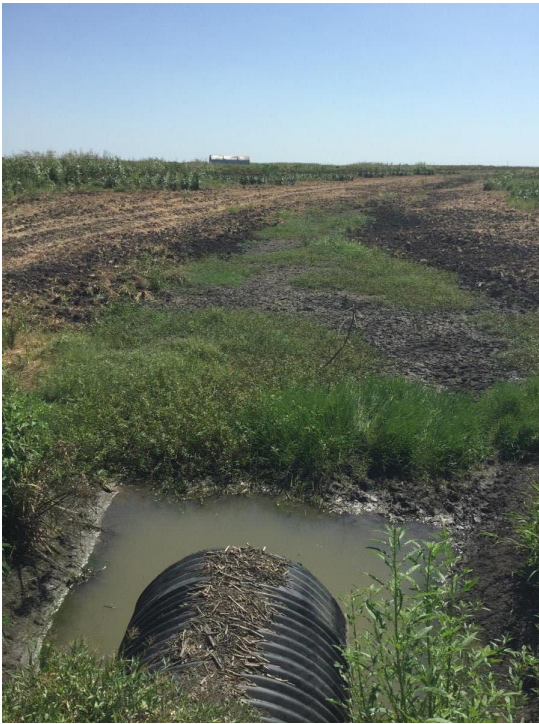
<b>Client:</b>	<b>Cutlass Solar II LLC</b>	<b>Project:</b>	<b>Waters of the United States Delineation</b>
<b>Project Name:</b>	<b>Cutlass Solar II Project</b>	<b>Project Location:</b>	<b>Fort Bend County, Texas</b>
<b>Photograph ID: 5</b>

<b>Photo Location:</b> ST-02			
<b>Direction:</b> SW			
<b>Survey Date:</b> 7/25/2019			
<b>Comments:</b> Upstream view of ST-02, an ephemeral stream. Representative view of the stream flowing northeast. Picture was taken on the Project boundary, facing southwest into the Project Area.			
<b>Photograph ID: 6</b>

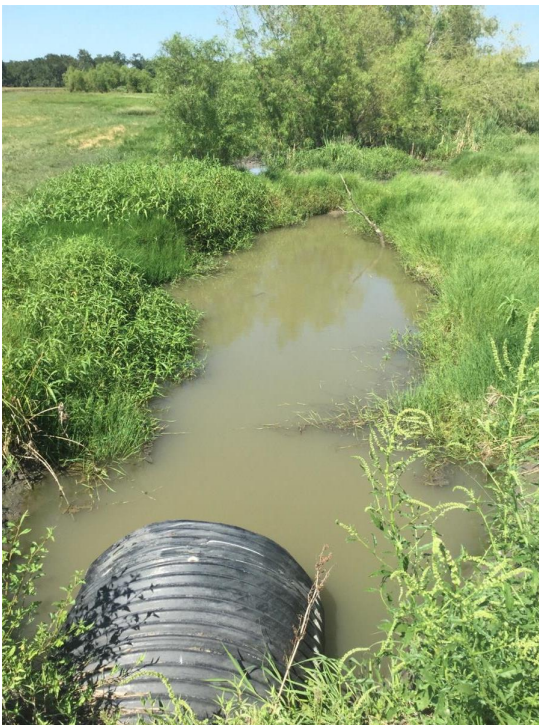
<b>Photo Location:</b> ST-02			
<b>Direction:</b> NE			
<b>Survey Date:</b> 7/25/2019			
<b>Comments:</b> Downstream view of ST-02, an ephemeral stream. Representative view of the stream flowing northeast, out of the Project Area. Picture was taken on the Project boundary, facing northeast outside of the Project Area.

Vegetation along ST-02 within the Project Area was primarily cultivated cropland that transitioned to a grassy area between the Project Area and the constructed wetland area, located on an adjacent property southeast of the Project Area.
