**Cutlass Solar II Project  
Fort Bend County, Texas  
Phase I Environmental Site  
Assessment**

Project No.: 235301350

**CUTLASS SOLAR II PROJECT  
FORT BEND COUNTY, TEXAS  
PHASE I ENVIRONMENTAL SITE ASSESSMENT**

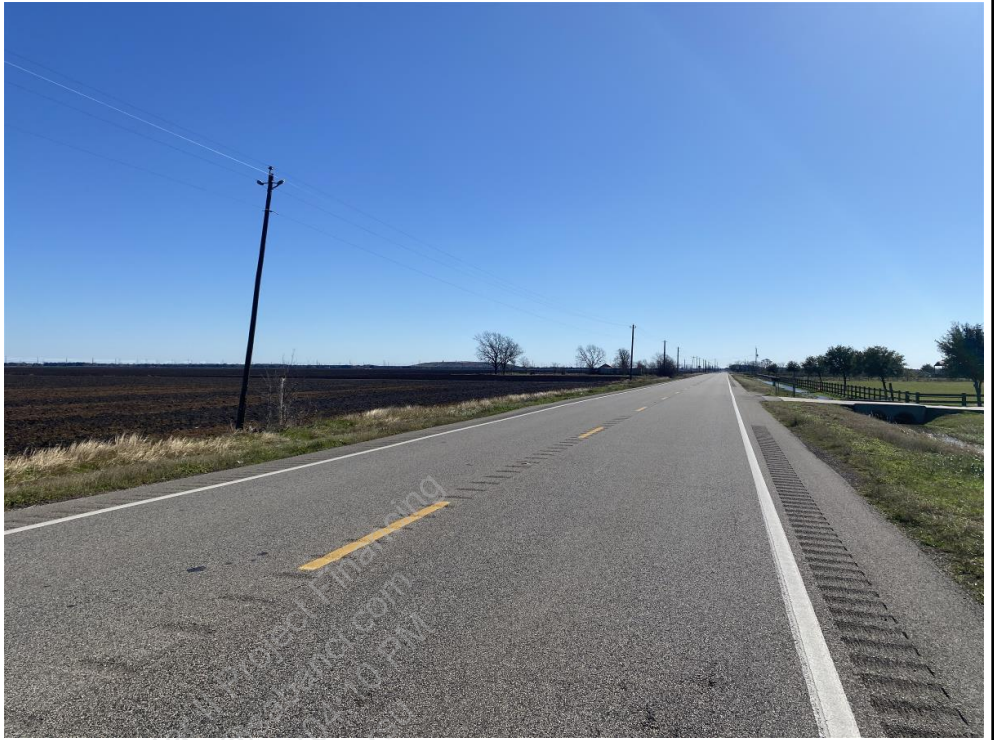
<b>Client:</b>	<b>Cutlass Solar II LLC</b>	<b>Project:</b>	<b>Phase I Environmental Site Assessment</b>
<b>Site Name:</b>	<b>Cutlass Solar II Project</b>	<b>Site Location:</b>	<b>Fort Bend County, Texas</b>
<b>Photograph ID:</b> 3

<b>Photo Location:</b> 29.414155, -95.761337			
<b>Direction:</b> Southeast			
<b>Survey Date:</b> 1/9/2024			
<b>Comments:</b> Reresentative view of Fairchilds-Long Point Road south of the Subject Property			
<b>Photograph ID:</b> 4

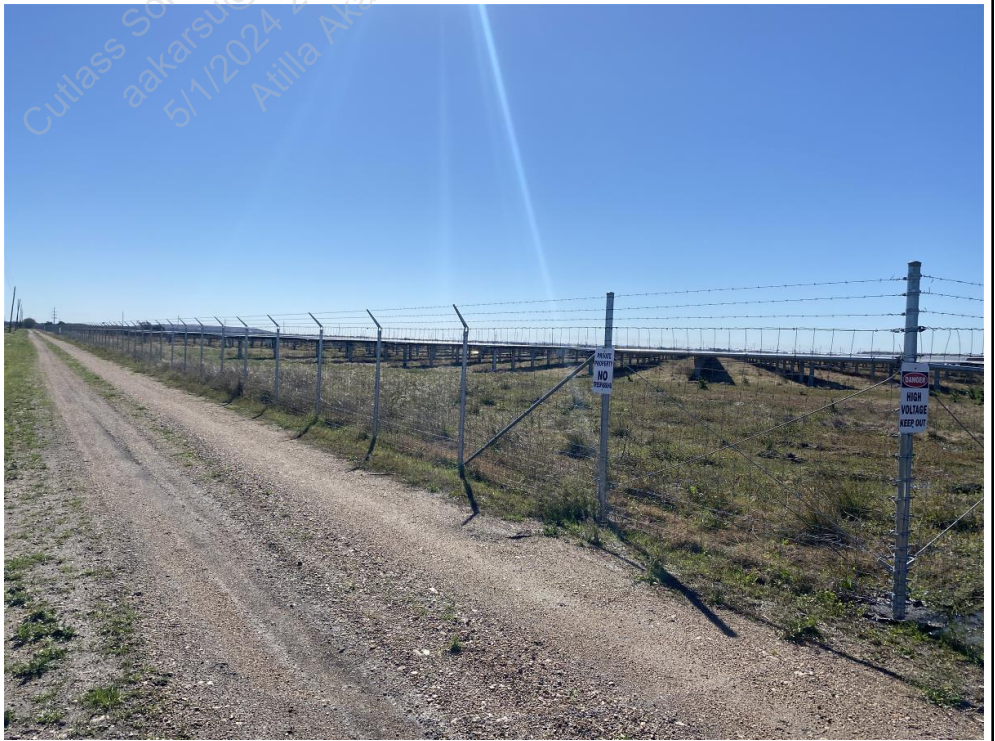
<b>Photo Location:</b> 29.433582, -95.748712			
<b>Direction:</b> Southeast			
<b>Survey Date:</b> 1/9/2024			
<b>Comments:</b> View of northern Subject Property boundary

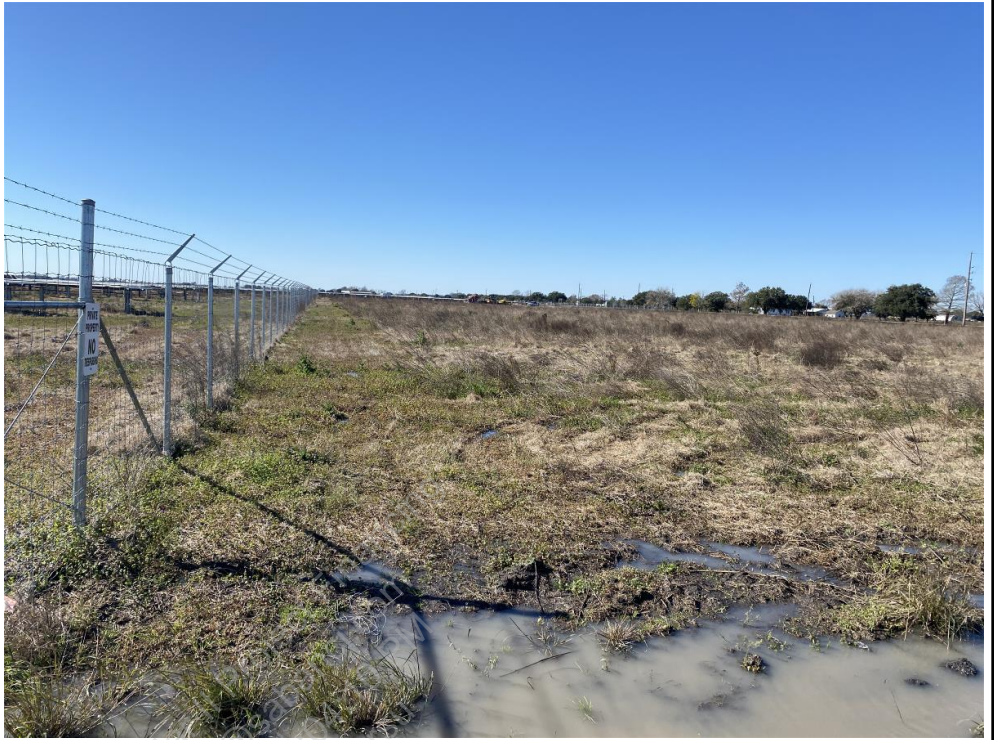
<b>Client:</b>	<b>Cutlass Solar II LLC</b>	<b>Project:</b>	<b>Phase I Environmental Site Assessment</b>
<b>Site Name:</b>	<b>Cutlass Solar II Project</b>	<b>Site Location:</b>	<b>Fort Bend County, Texas</b>
<b>Photograph ID:</b> 5

<b>Photo Location:</b> 29.433582, -95.748712			
<b>Direction:</b> Southwest			
<b>Survey Date:</b> 1/9/2024			
<b>Comments:</b> View of northwestern Subject Property boundary			
<b>Photograph ID:</b> 6

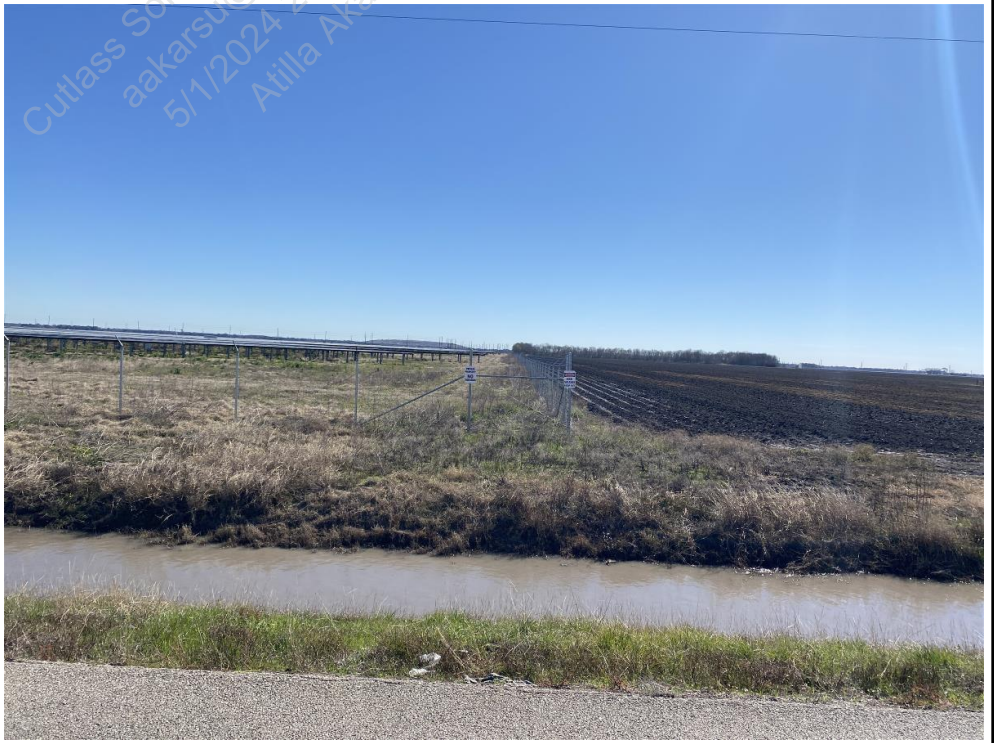
<b>Photo Location:</b> 29.423416, -95.759928			
<b>Direction:</b> Southeast			
<b>Survey Date:</b> 1/9/2024			
<b>Comments:</b> View of western Subject Property boundary

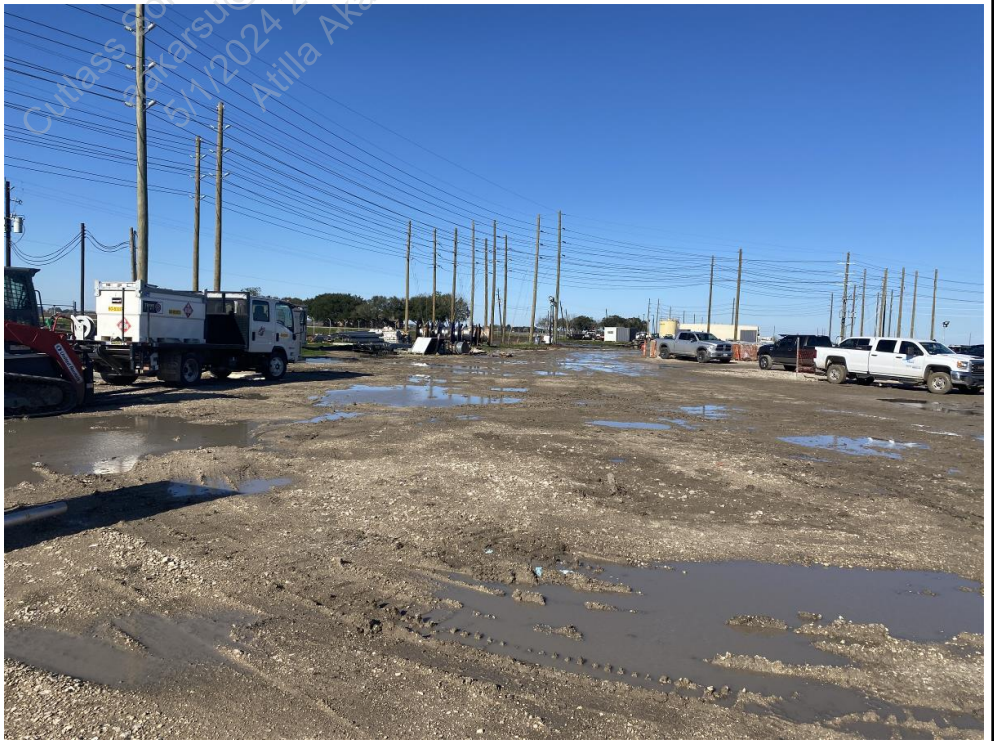
<b>Photo Location:</b> 29.401035, -95.744201			
<b>Direction:</b> Northwest			
<b>Survey Date:</b> 1/9/2024			
<b>Comments:</b> Representative view of the adjacent Cutlass Solar I laydown yard.

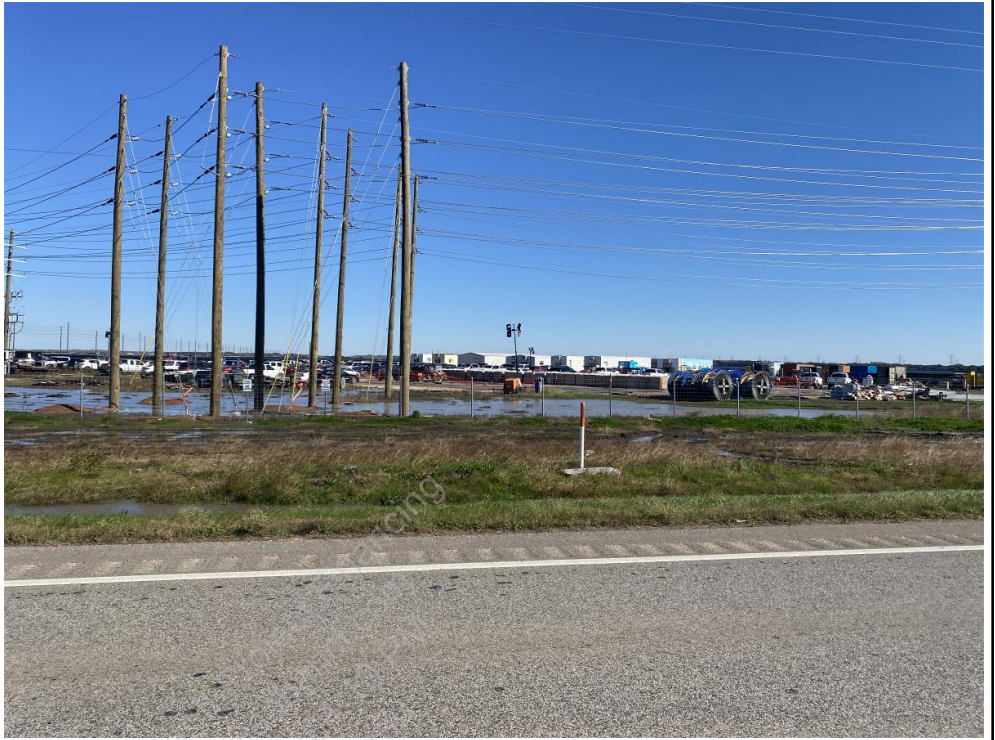
<b>Client:</b>	<b>Cutlass Solar II LLC</b>	<b>Project:</b>	<b>Phase I Environmental Site Assessment</b>
<b>Site Name:</b>	<b>Cutlass Solar II Project</b>	<b>Site Location:</b>	<b>Fort Bend County, Texas</b>
<b>Photograph ID:</b> 13

<b>Photo Location:</b> 29.401291, -95.745542			
<b>Direction:</b> Northeast			
<b>Survey Date:</b> 1/9/2024			
<b>Comments:</b> Representative view of the adjacent Cutlass Solar I laydown yard and offices.			
<b>Photograph ID:</b> 14	 		
<b>Photo Location:</b> 29.401035, -95.744201			
<b>Direction:</b> East			
<b>Survey Date:</b> 1/9/2024			
<b>Comments:</b> Portable restroom facilities located in the Cutlass Solar I laydown yard.

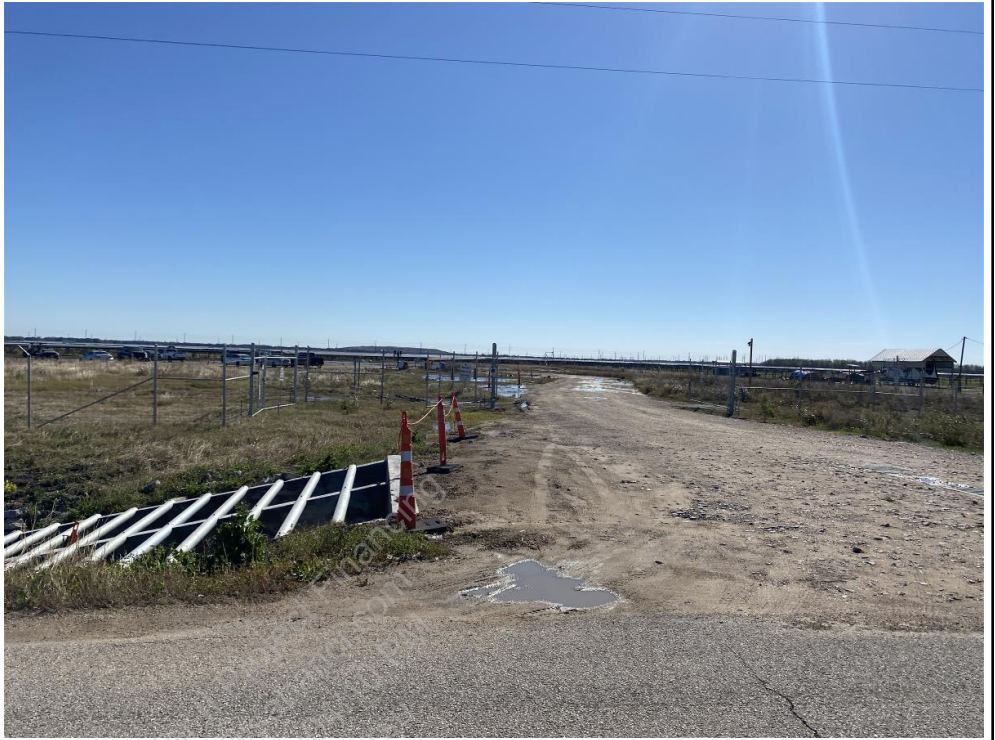
<b>Client:</b>	<b>Cutlass Solar II LLC</b>	<b>Project:</b>	<b>Phase I Environmental Site Assessment</b>
<b>Site Name:</b>	<b>Cutlass Solar II Project</b>	<b>Site Location:</b>	<b>Fort Bend County, Texas</b>
<b>Photograph ID:</b> 29

<b>Photo Location:</b> 29.427045, -95.755683			
<b>Direction:</b> Southeast			
<b>Survey Date:</b> 1/9/2024			
<b>Comments:</b> Gate 3 along the western boundary of the Subject Property.			
<b>Photograph ID:</b> 30

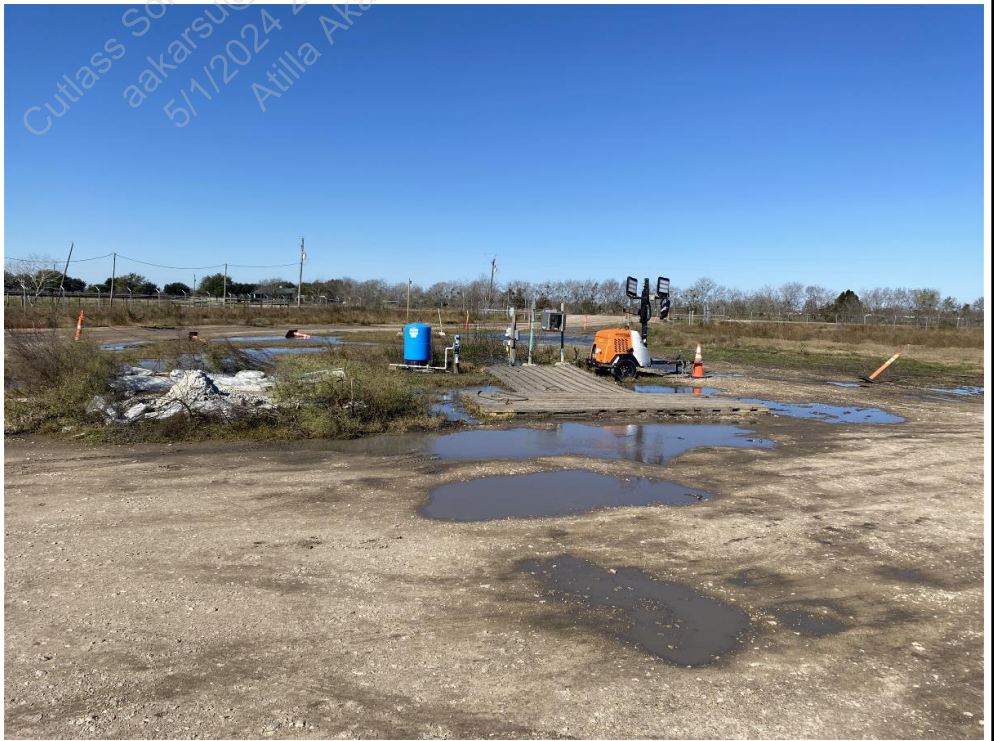
<b>Photo Location:</b> 29.426432, -95.754748			
<b>Direction:</b> Northwest			
<b>Survey Date:</b> 1/9/2024			
<b>Comments:</b> A domestic water well in the western portion of the Subject Property was reported to have been placed out of service.

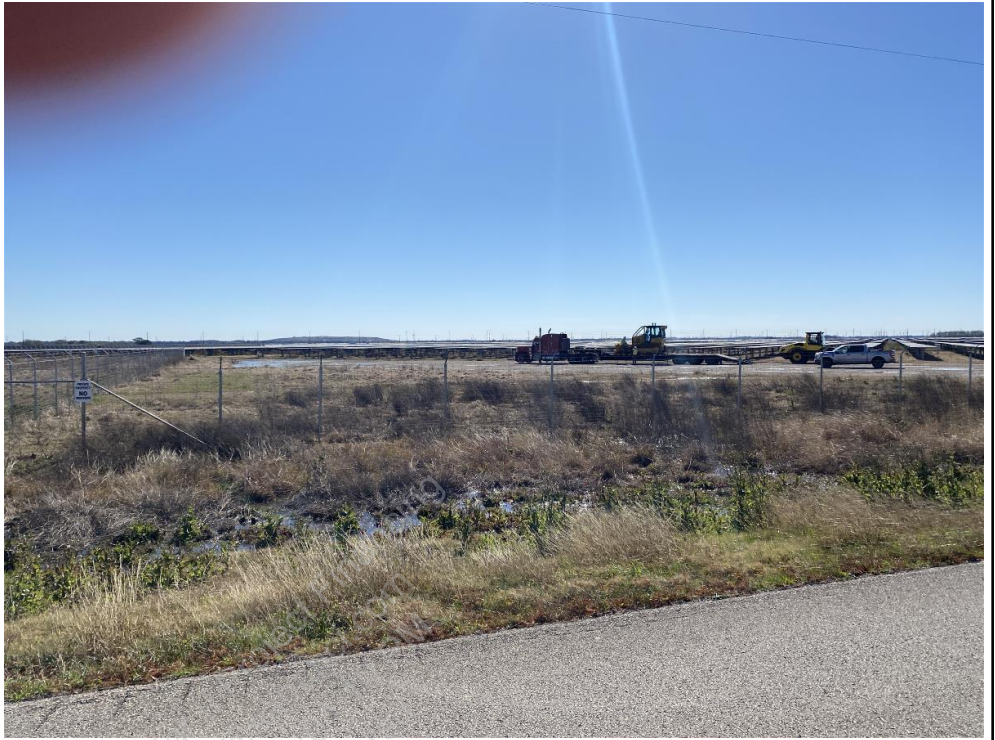
<b>Client:</b>	<b>Cutlass Solar II LLC</b>	<b>Project:</b>	<b>Phase I Environmental Site Assessment</b>
<b>Site Name:</b>	<b>Cutlass Solar II Project</b>	<b>Site Location:</b>	<b>Fort Bend County, Texas</b>
<b>Photograph ID:</b> 33

<b>Photo Location:</b> 29.432322, -95.750007			
<b>Direction:</b> South			
<b>Survey Date:</b> 1/9/2024			
<b>Comments:</b> A laydown yard was observed in the northern portion of the Subject Property near gate 4.			
<b>Photograph ID:</b> 34

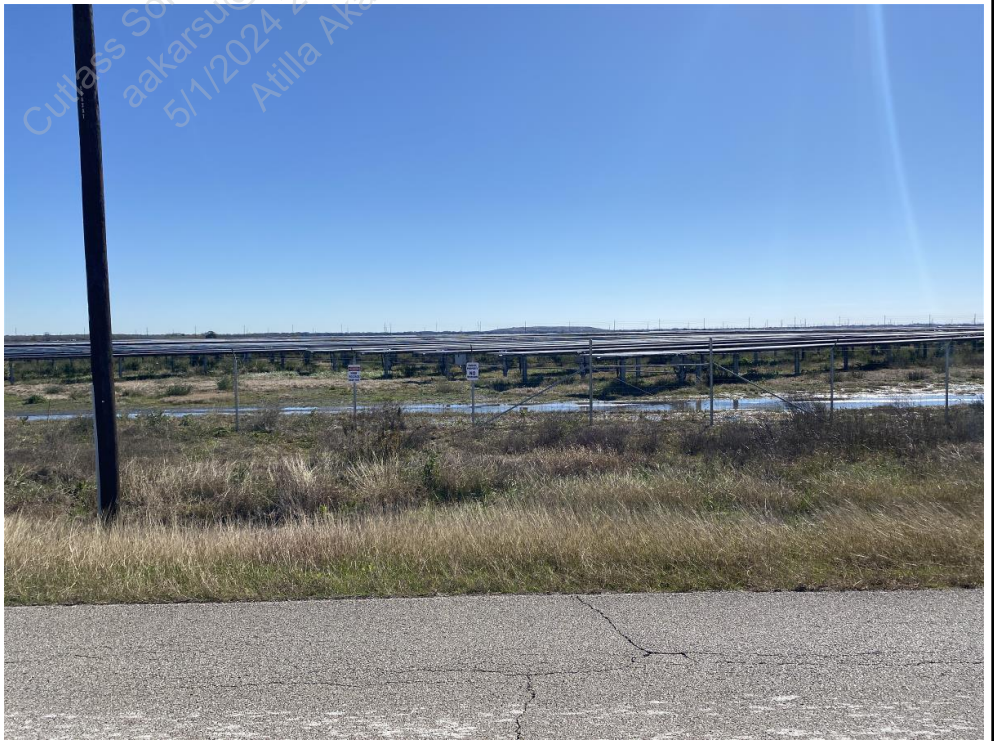
<b>Photo Location:</b> 29.428856, -95.753724			
<b>Direction:</b> Southeast			
<b>Survey Date:</b> 1/9/2024			
<b>Comments:</b> Representative view of installed solar panels along Boothline Road.

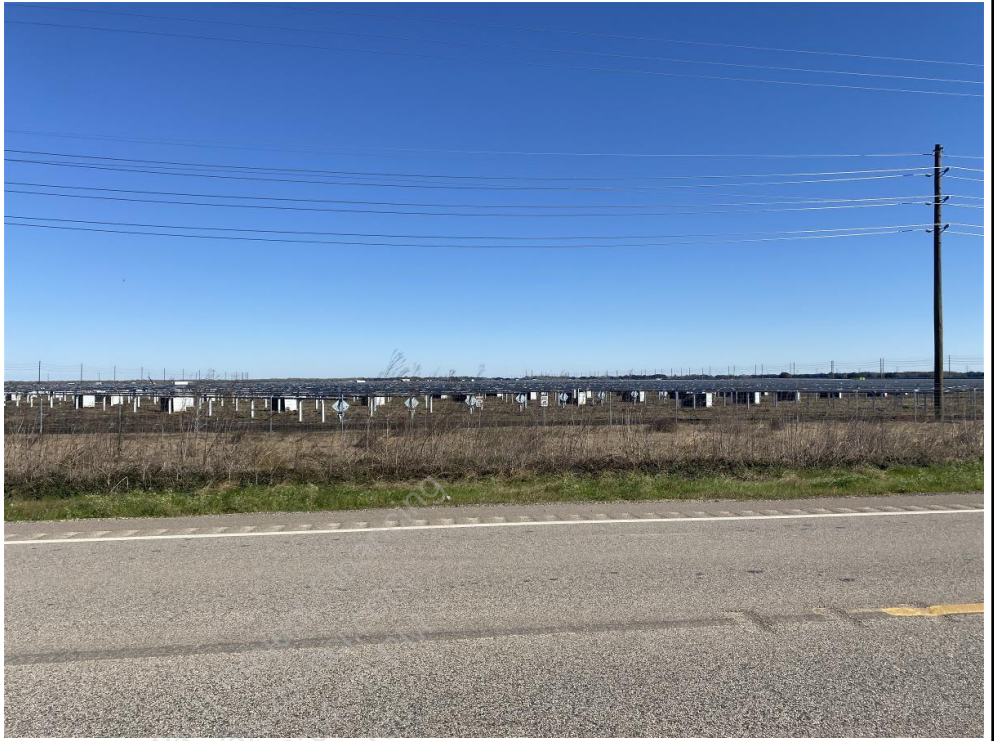
<b>Client:</b>	<b>Cutlass Solar II LLC</b>	<b>Project:</b>	<b>Phase I Environmental Site Assessment</b>
<b>Site Name:</b>	<b>Cutlass Solar II Project</b>	<b>Site Location:</b>	<b>Fort Bend County, Texas</b>
<b>Photograph ID:</b> 35

<b>Photo Location:</b> 29.404173, -95.749210			
<b>Direction:</b> Northeast			
<b>Survey Date:</b> 1/9/2024			
<b>Comments:</b> Southern boundary of Subject Property along Fairchilds-Long Point Road.
